Monthly Owners Inspection History

BID: 3459 - Randwick Industrial Park, 39 Randwick Road, Moera, Lower Hutt

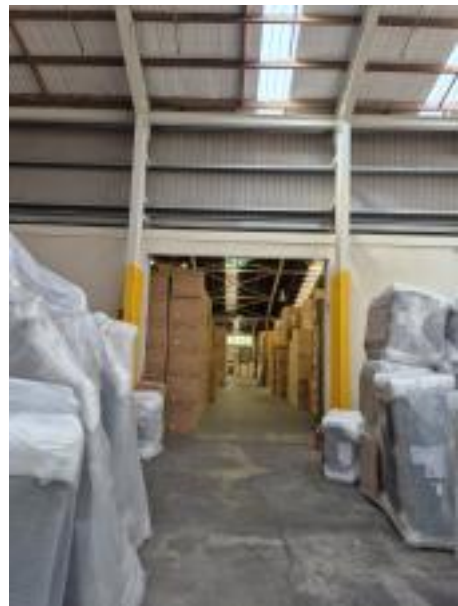
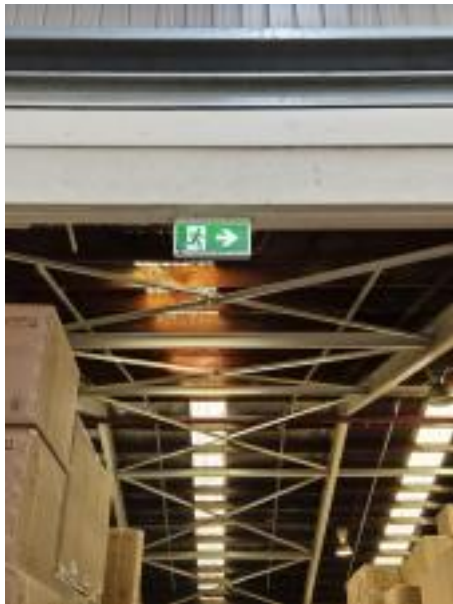
Inspector comments:
Exit sign with arrow pointing right is misleading as there is no exit to the right. Exit is straight ahead from where it is visible.
Recommend replacement.
